**An evaluation of the ecological impacts of sand mining on the Mokolo River
in Lephalale, South Africa**

submitted in accordance with the requirements
for the degree of

MASTER OF SCIENCE

ENVIRONMENTAL SCIENCE

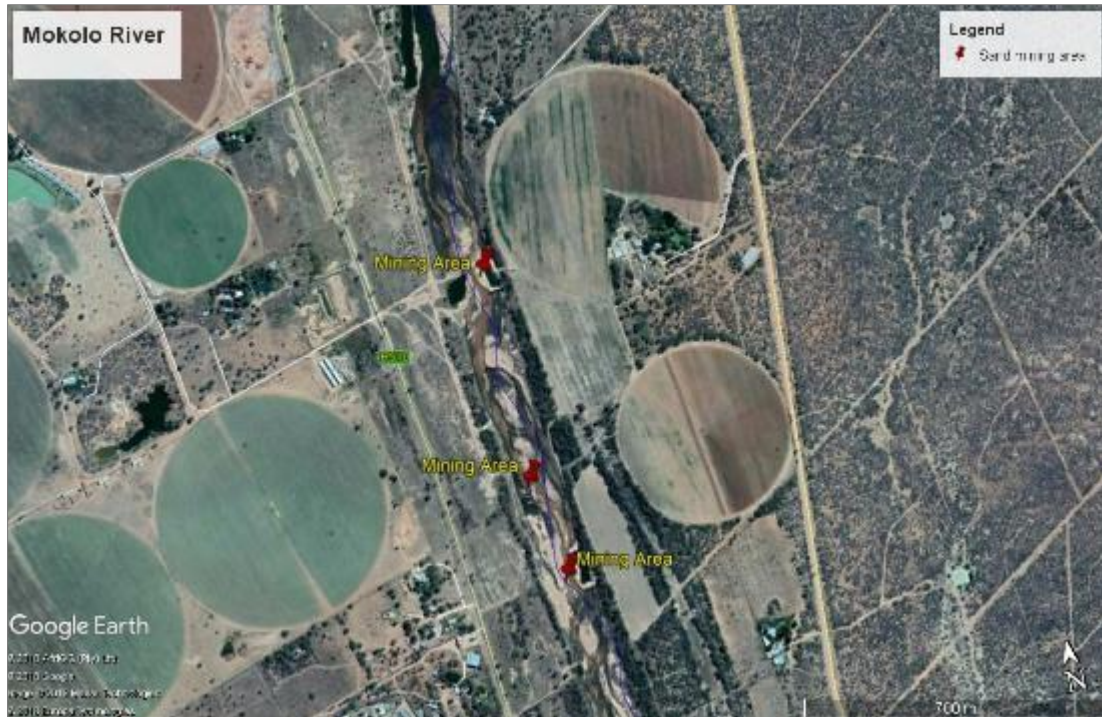
Figure 3.2: Map showing sand mining activity in the Mokolo River (Google Earth, 2018)

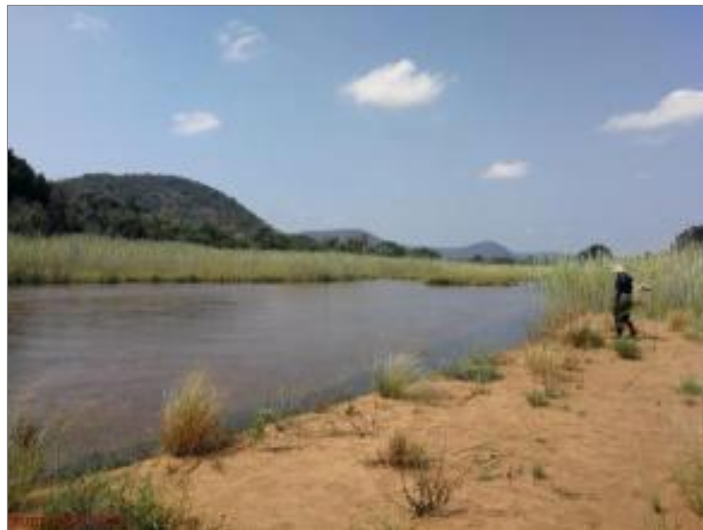
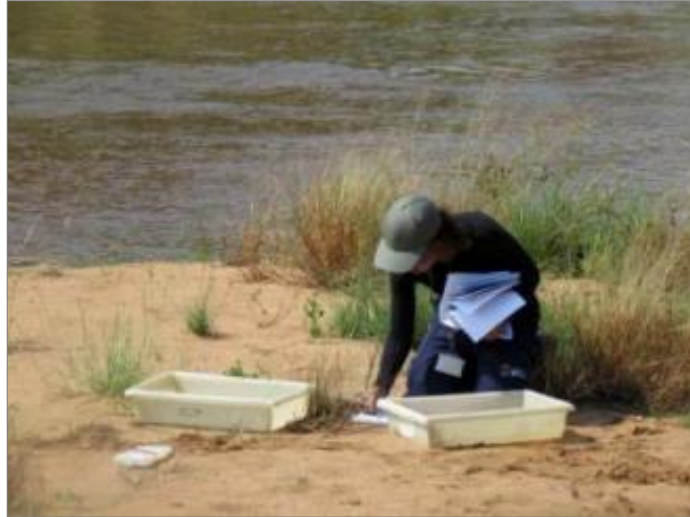
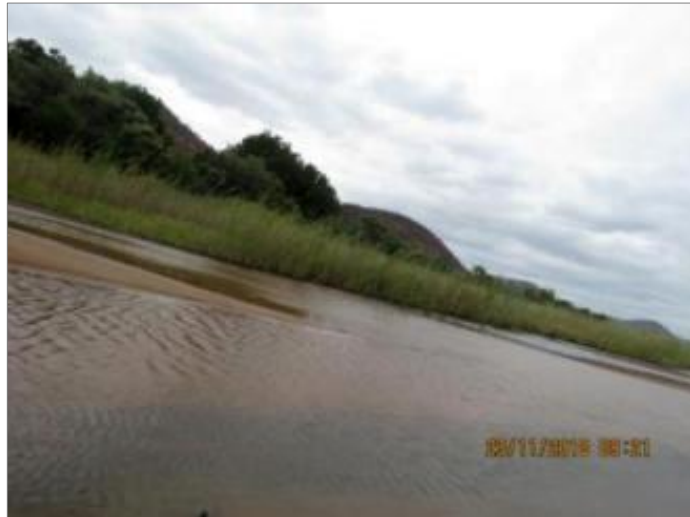
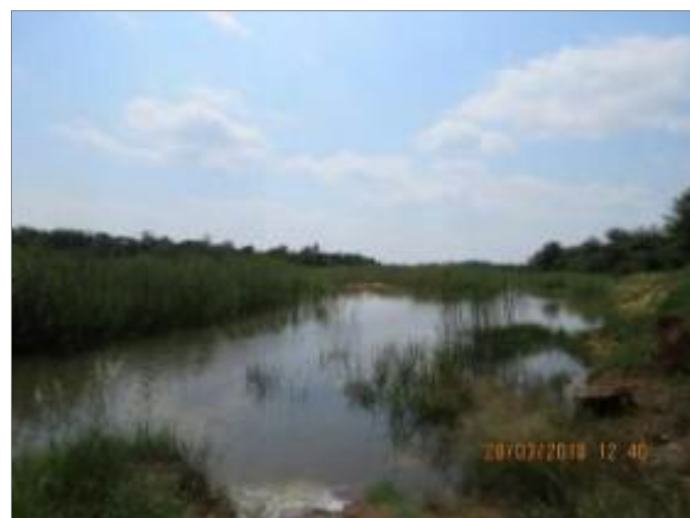
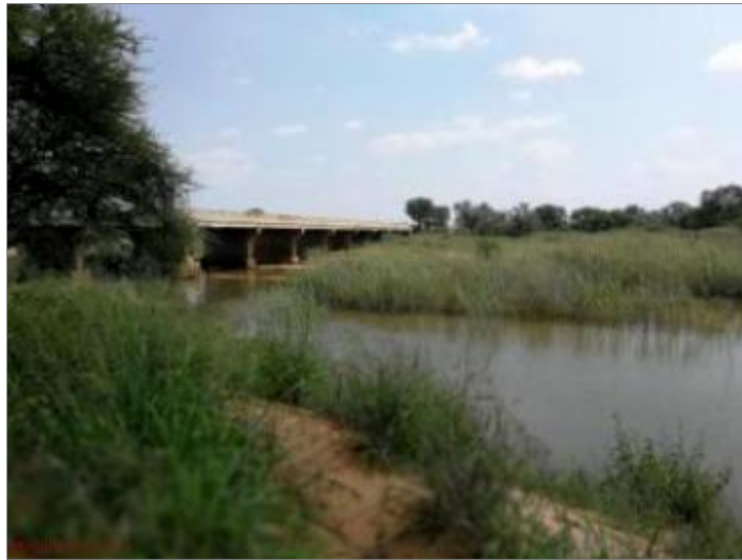
There was no sand mining at the upstream and downstream of the Mokolo River. There is no loss of riparian and marginal vegetation, erosion, collapsing of riverbanks, disturbed riverbed, instream sand stockpiles, river diversion and in-stream dams due to sand mining at the upstream and downstream of the Mokolo River (Figs. 4.15 to 4.19).

**Figure 4.15:** Upstream area before sand mining

Figure 4.16: River health assessment at upstream area and no sand mining

Figure 4.17: Upstream and no sand mining

Figure 4.18: Downstream area and no sand mining

Figure 4.19: Downstream area and no sand mining impacts

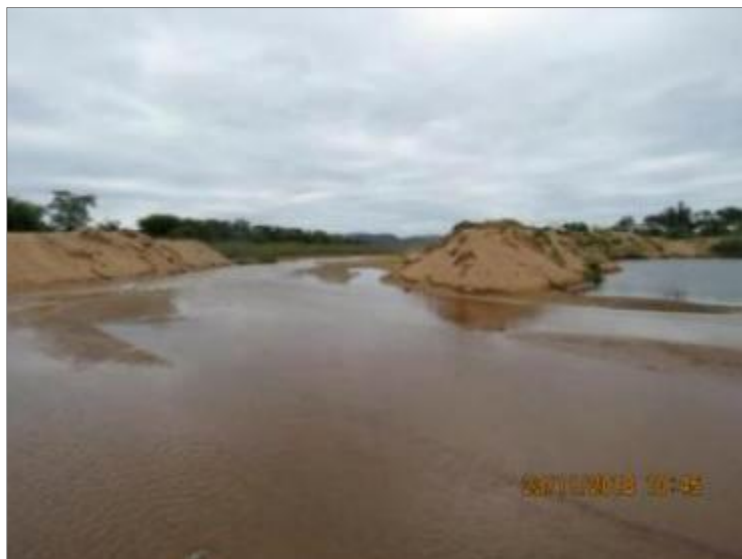
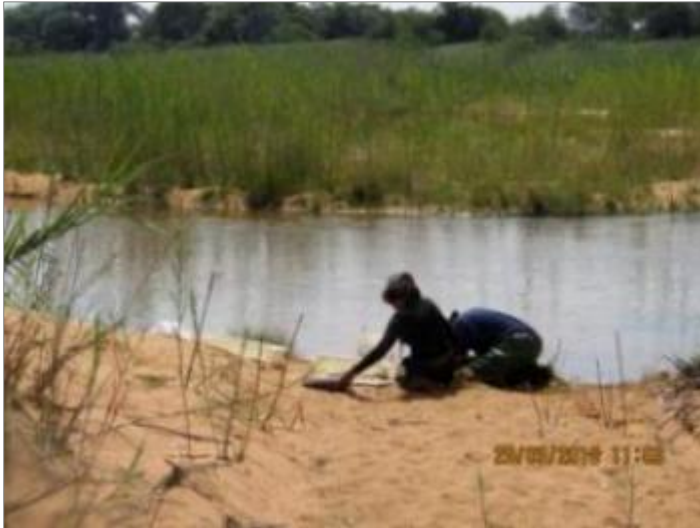
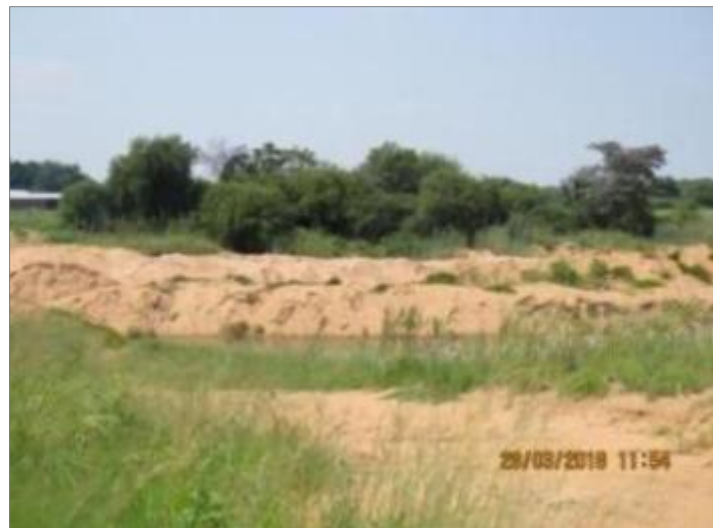
During sand mining, there is use of heavy machineries, river diversions are created which diverts natural flow of the water in a river and less water flows to the downstream area (Fig. 4.20 to 4.27). The physical disturbances of removal of riparian and marginal vegetation (Fig. 4.23), erosion and loss of adjacent land, collapsing of riverbanks, disturbed riverbed (Fig. 4.24), water pools and blockage of water flow with sand (Fig. 4.25 and 4.27), river diversions (Fig. 4.26), instream sand stockpiles, instream dams and abstraction were recorded at the sand mining area of the Mokolo River).

Figure 4.20: Sand mining area

Figure 4.21: River health assessment at mining area

Figure 4.22: Mining area and instream sand stockpiles

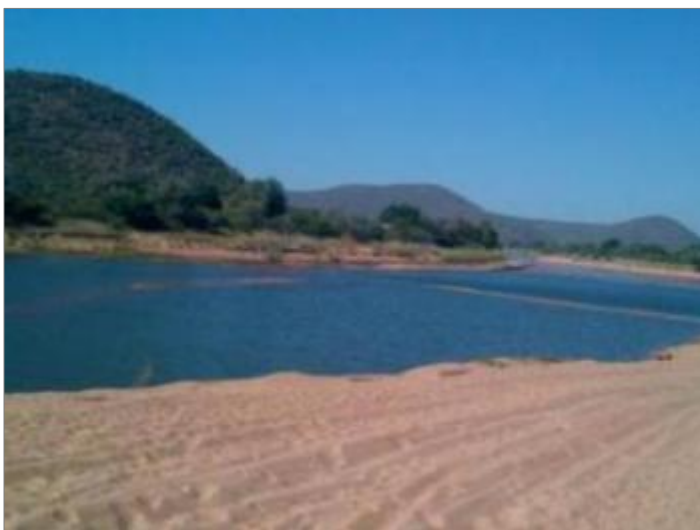
Figure 4.23: Removal of riparian and marginal vegetation and loss of adjacent land

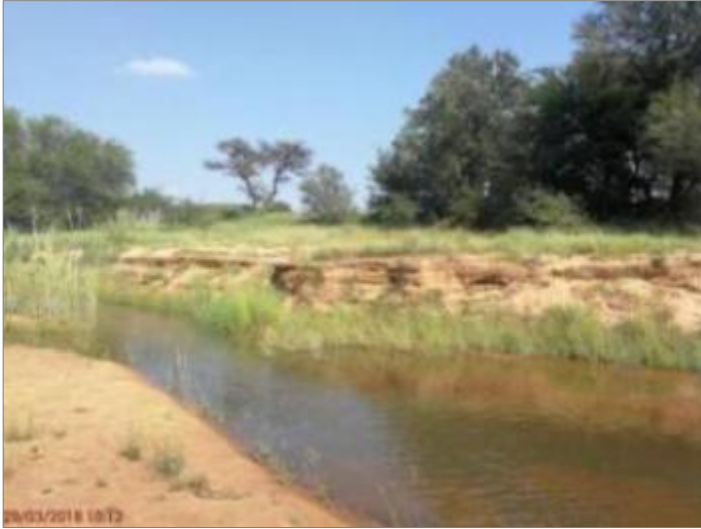
Figure 4.24: Erosion, undercutting and collapsing of riverbanks at sand mining area

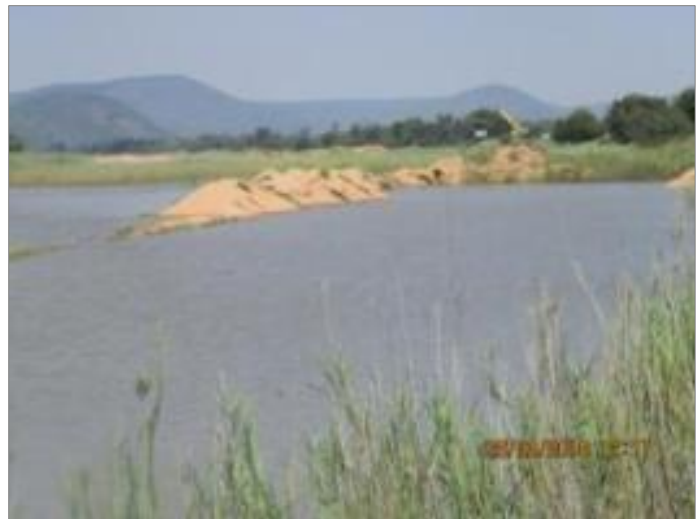
Figure 4.25: Blockage of water flow and instream sand stockpile within the river

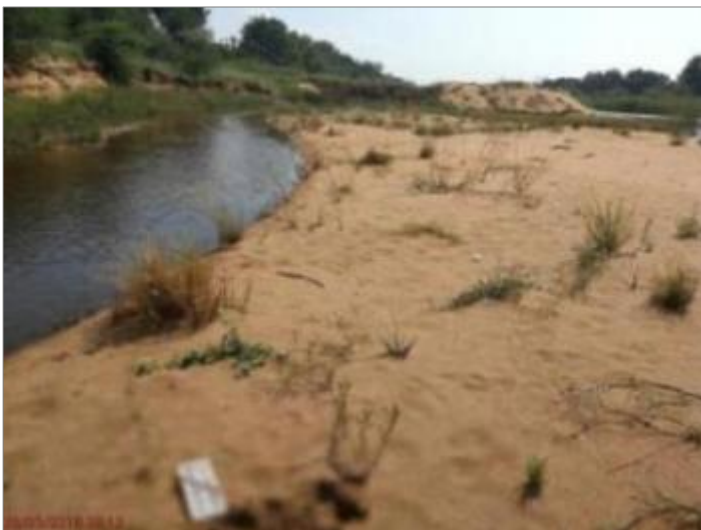
Figure 4.26: River diversions and instream sand stockpiles within the river

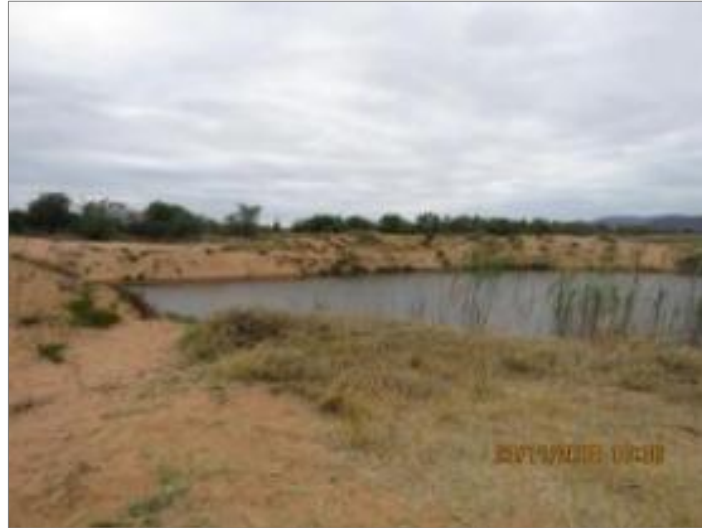
Figure 4.27: Blockage of flow and pool of water
